STATE OF NEW HAMPSHIRE
BEFORE THE
NEW HAMPSHIRE PUBLIC UTILITIES COMMISSION

PUBLIC SERVICE COMPANY OF NEW HAMPSHIRE
RECONCILIATION OF ENERGY SERVICE AND STRANDED COSTS FOR
CALENDAR YEAR 2009

DIRECT TESTIMONY OF
WILLIAM H. SMAGULA

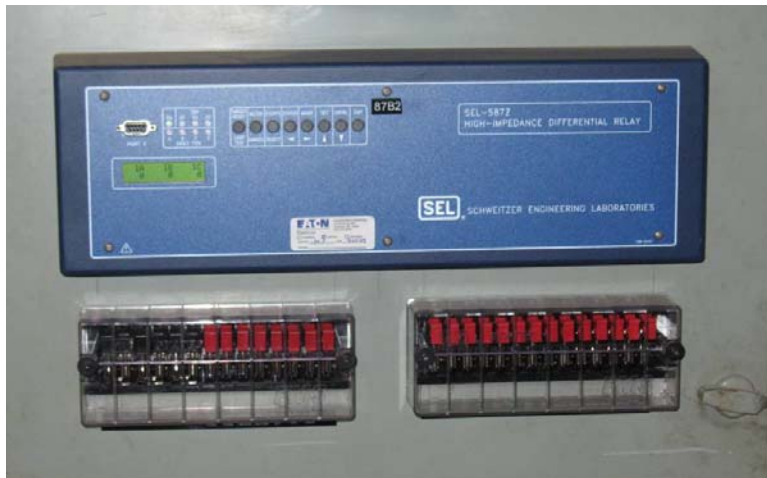
Photo 1

Critical path activities for the outage involved the installation of a 4160V Bus Differential Protection for Bus 1 & 2, and 480V Bus Overcurrent Protection for Power Centers 1LA, 1LB & 1LC. Each protection scheme required the installation of new Schweitzer digital relays, associated test switches, shorting blocks, wiring and current transformers (CT's). The project required the relocation of some of the existing CT's and the installation of 48 new CT's which required sections of the bus to be de-energized and dismantled. CT's were installed on all three phases, at each feeder, main and tie breaker for the bus differential scheme. The bus overcurrent protection schemes required new CT's to be installed on all three phases, of the low voltage side, of the load center transformers. One of the new bus differential relays is shown in photo 1.

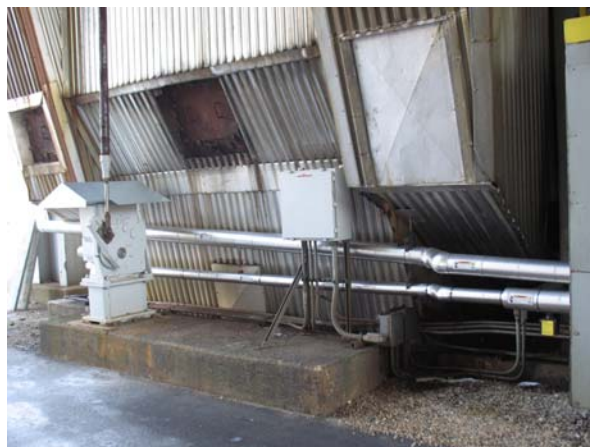
Photo 2

ID Fan Lube Oil Piping: Recent inspections revealed various sections of supply/return lube oil piping were in need of replacement. During this outage maintenance technicians replaced sections of corroded piping on both lube oil systems. Sections of piping were cut out, new piping was welded in and new pipe supports were replaced as needed. The plant electricians installed new heat trace cable and controllers for each lube oil system. New insulated lube oil piping is shown below in photo #2.

Prior to placing the systems back in service, temporary strainers were installed at the bearing housings and the systems were flushed.
