Docket No. DE 10-XXX Exhibit No. 3

PUBLIC SERVICE COMPANY OF NEW HAMPSHIRE RECONCILIATION OF ENERGY SERVICE AND STRANDED COSTS FOR CALENDAR YEAR 2009

DIRECT TESTIMONY OF WILLIAM H. SMAGULA

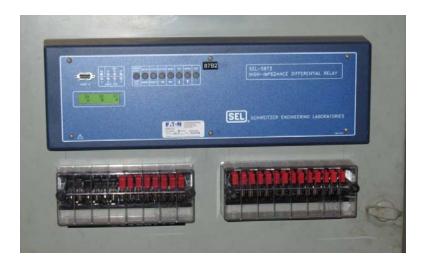
Photo 1

Critical path activities for the outage involved the installation of a 4160V Bus Differential Protection for Bus 1 & 2, and 480V Bus Overcurrent Protection for Power Centers 1LA, 1LB & 1LC. Each protection scheme required the installation of new Schweitzer digital relays, associated test switches, shorting blocks, wiring and current transformers (CT's). The project required the relocation of some of the existing CT's and the installation of 48 new CT's which required sections of the bus to be de-energized and dismantled. CT's were installed on all three phases, at each feeder, main and tie breaker for the bus differential scheme. The bus overcurrent protection schemes required new CT's to be installed on all three phases, of the low voltage side, of the load center transformers. One of the new bus differential relays is shown in photo 1.
