ORIGINAL
N.H.P.U.C. Case No. <u>DG 15-121</u>
Exhibit No. <u># 2</u>
Witness <u>Panel #1 and Panel #2</u>
DO NOT REMOVE FROM FILE

DG 15-121
Hearing on Notices of Violations

Re: Liberty Utilities, New Hampshire Gas Division
Notice of Probable Violations of Natural Gas Pipeline Safety Act and
NH Code of Administrative Rules Part 500
Control# PS1402LU
Pipelines Affected:

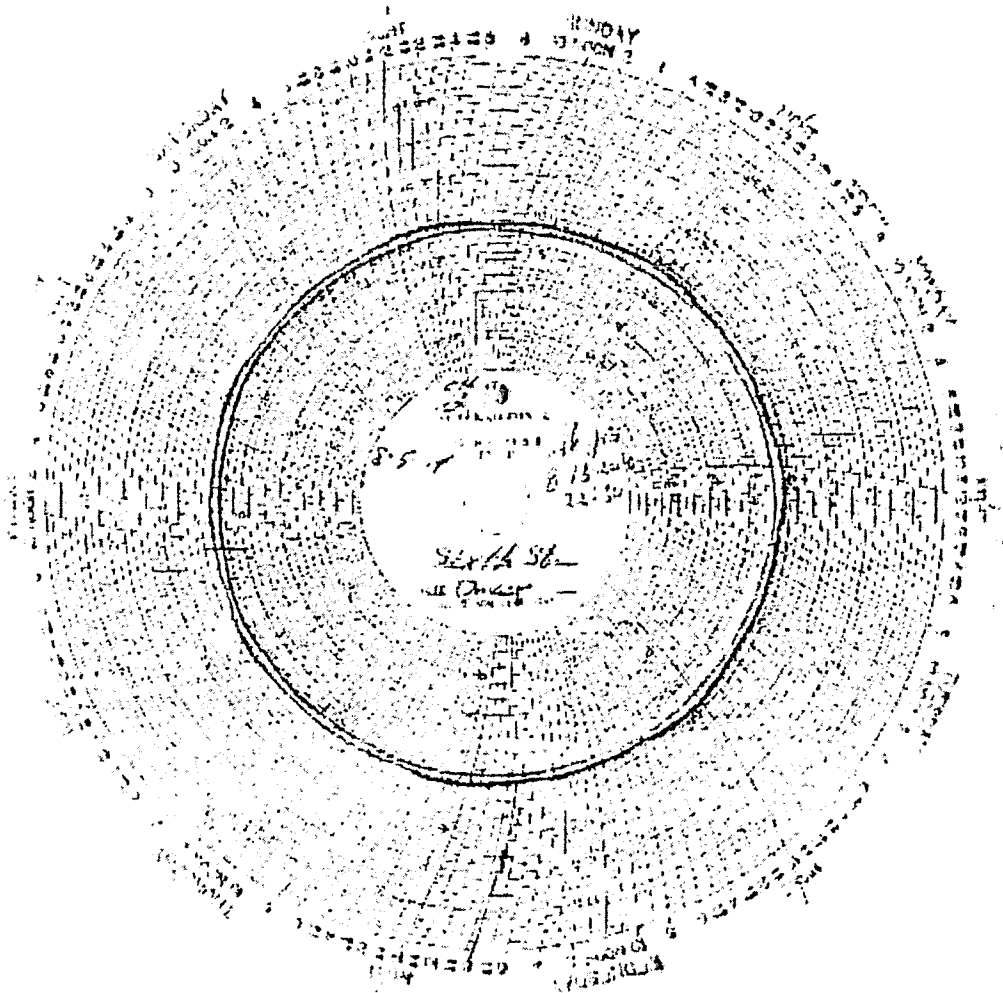
Exhibit 2 – Sixth St., Dover Pressure Recorder Chart

Identification of the overpressure condition by Gas Control Dispatcher and quick response by the Systems Operations Technician limited the extent of the overpressurization. Immediate leak surveys conducted by Distribution Technicians confirmed that despite the overpressurization, system integrity was maintained and there was no danger to the public. Remediation efforts have been assessed and implemented.

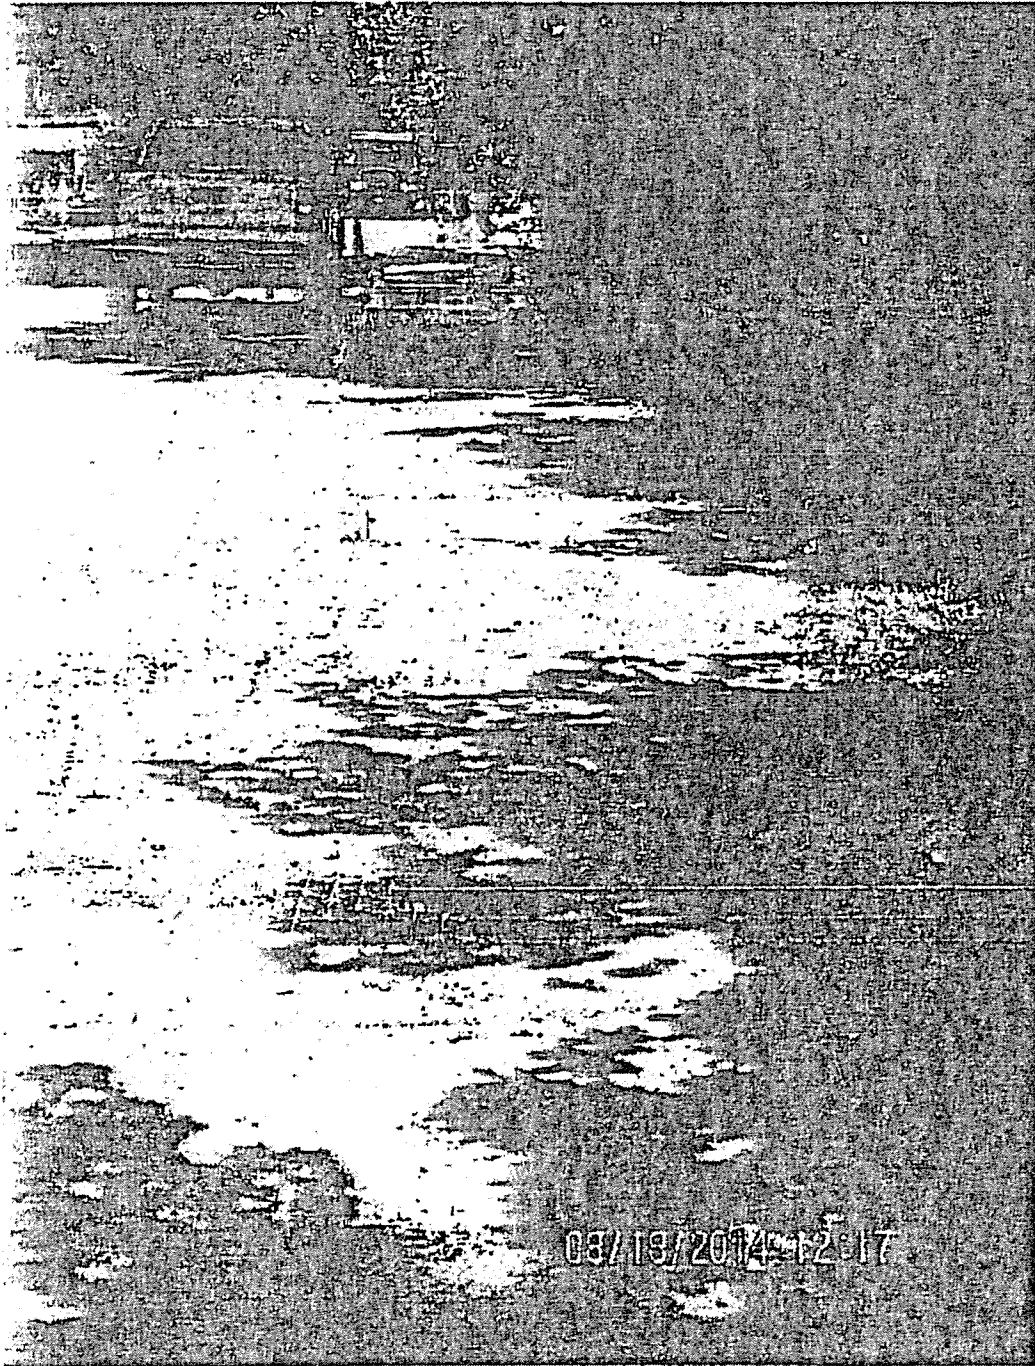
Exhibit 6 – Rutland St. Sidewalk Construction

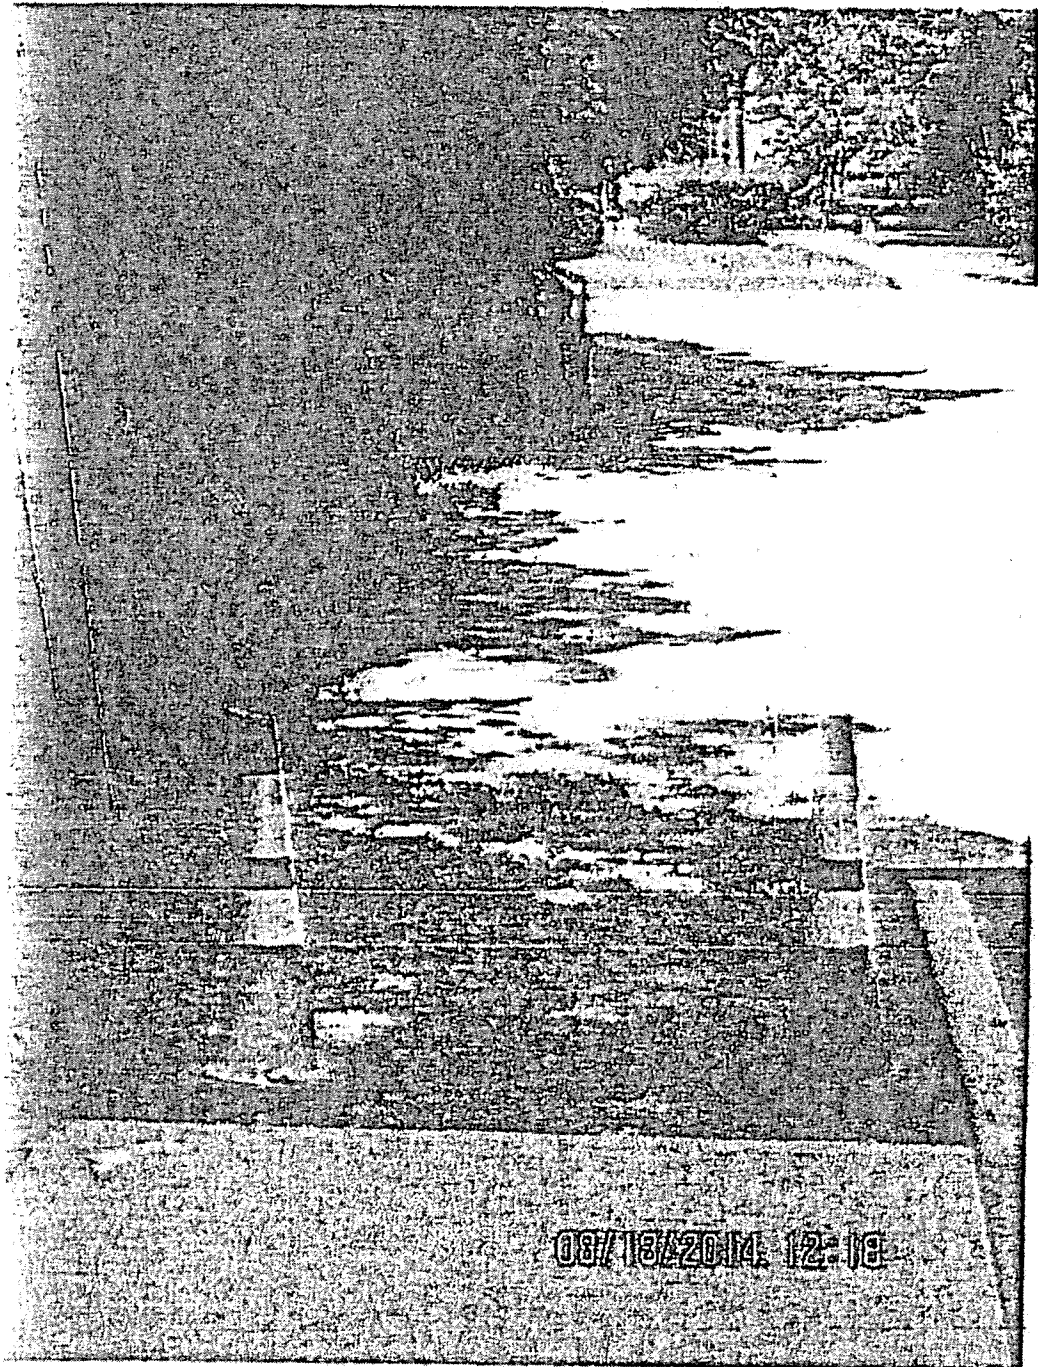
Exhibit 7 – Rutland St. Sidewalk Construction

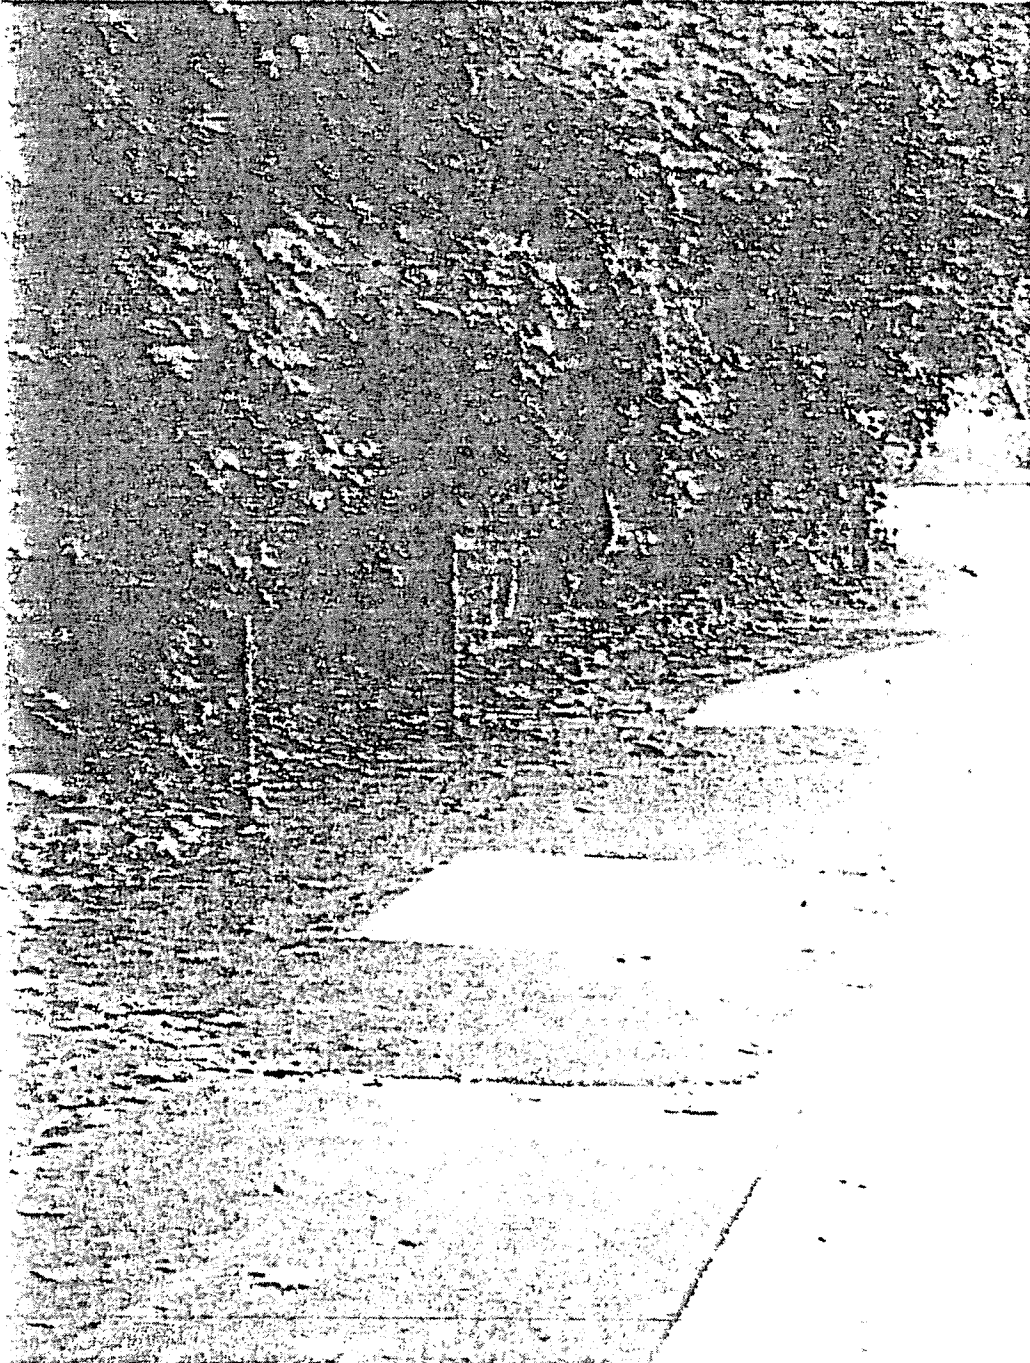
Exhibit 8 – Rutland St. Aboveground Vents and Paving

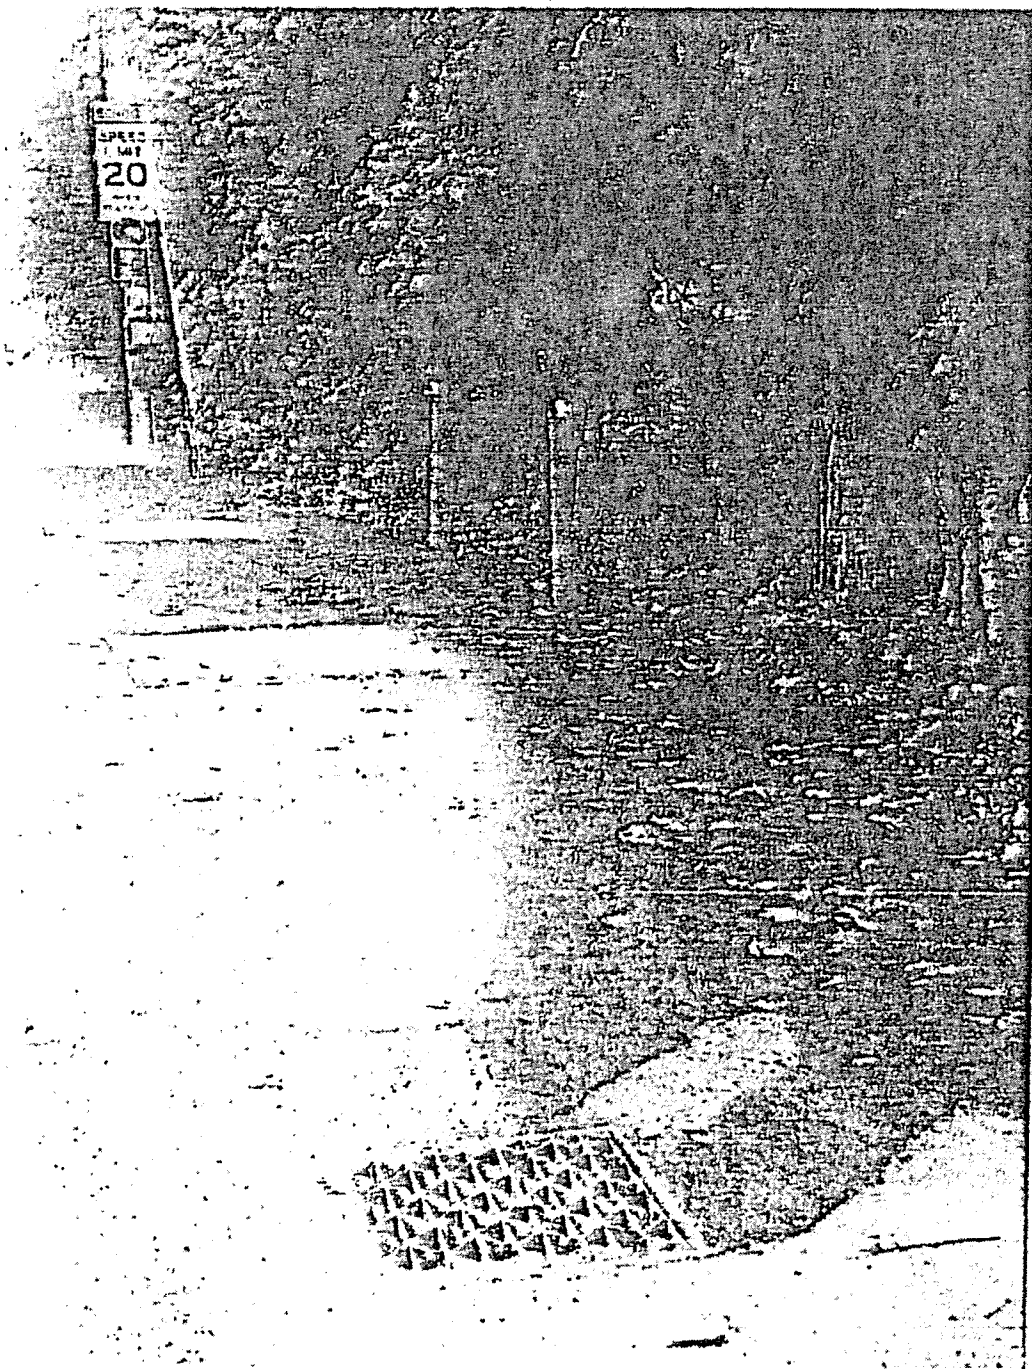
Exhibit 9 – Rutland St. Aboveground Vents and Paving

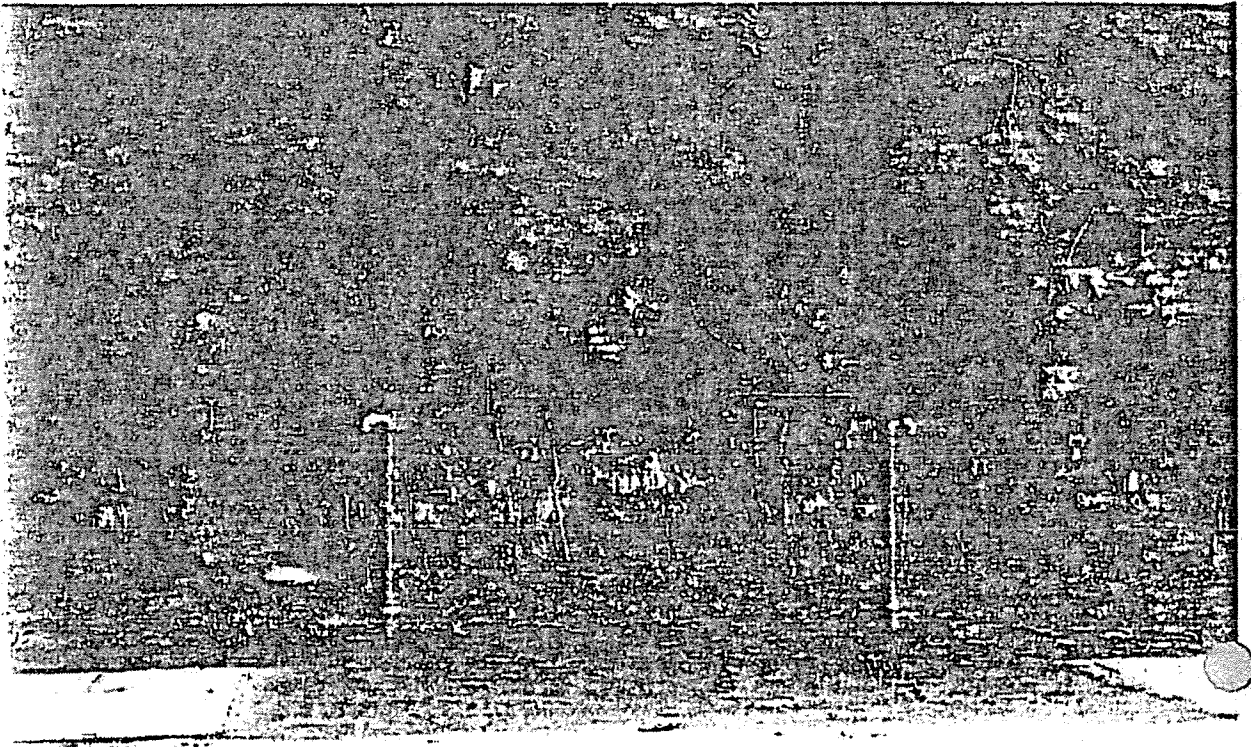
Exhibit 10 – Rutland St. Aboveground Vents and Paving
