**IR 15-517 NHPUC SAFETY DIVISION
INVESTIGATION REPORT
March 31, 2016
Of
DECEMBER 19, 2015 OPERATIONAL EVENT
LIBERTY UTILITIES - KEENE, NH DIVISION**

**IR 15-517 NHPUC SAFETY DIVISION
INVESTIGATION REPORT
DECEMBER 19, 2015 OPERATIONAL INCIDENT
LIBERTY UTILITIES KEENE DIVISION**

**Appendix 1-E, New Hampshire Public Utilities Commission
Gas Safety Division Investigation Report
Liberty Utilities December 19, 2015 Operational Event
Emerald St. Propane/Air Plant Component Photo Documentation**

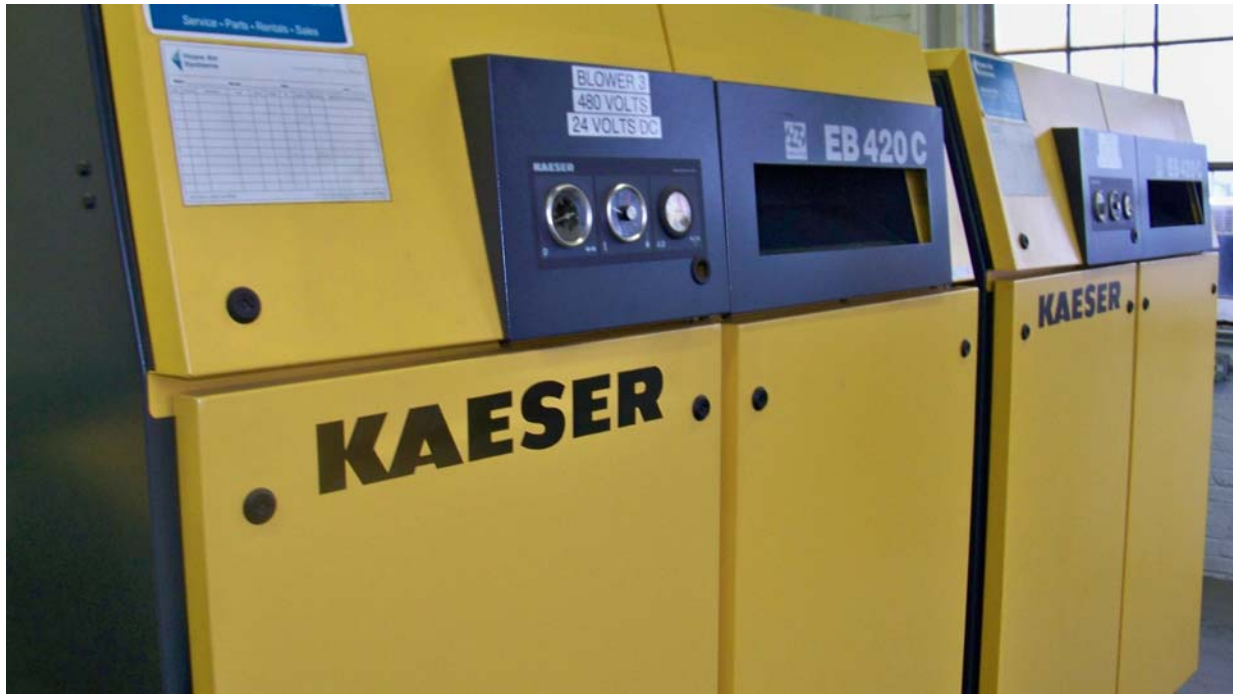
Liberty Keene – The plant mixes propane with air supplied by the blowers shown above.

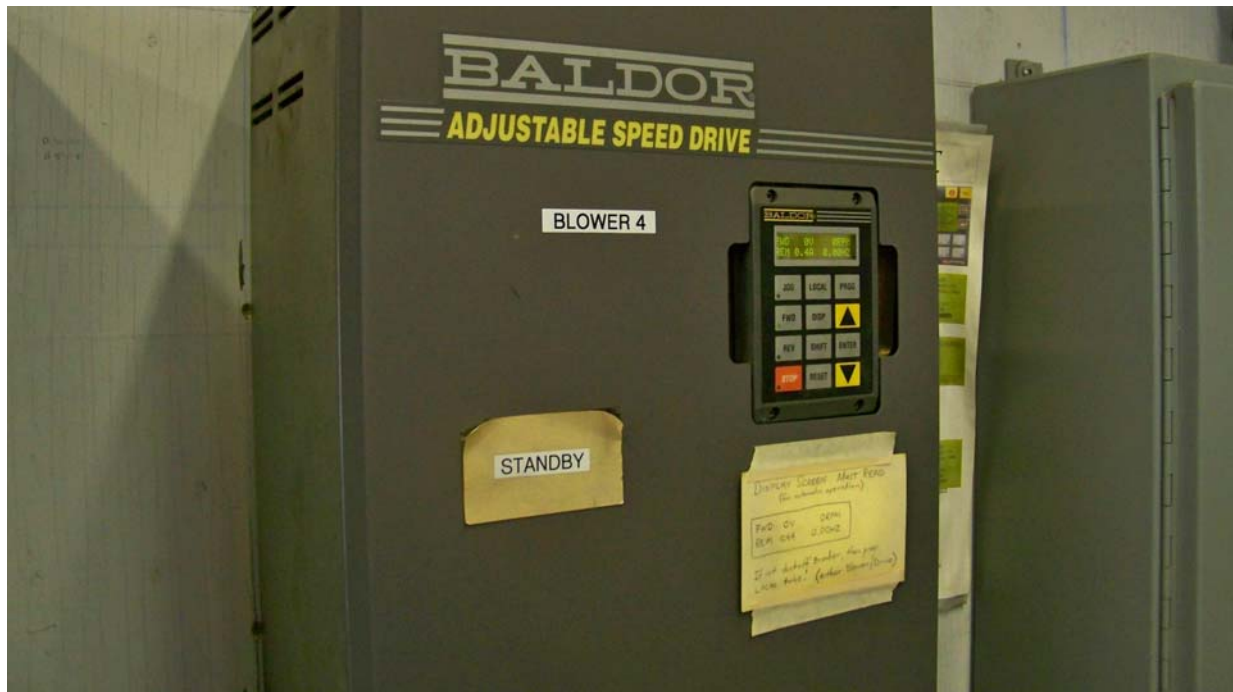
The July 2014 occasion was caused by a severe lightning storm. While there was no recorded power failure, the Adjustable Speed Drives of the blowers went into lockout most likely due to a voltage spike or drop in the power supply. All three events resulted in an improper mix of the propane vapor and air due to the loss of the forced air supply. On all three occasions, the system successfully transitioned to atmospheric safe mode which provided time for personnel to restore the systems to normal operations with a relatively small amount of the rich mixture entering the system. Staff also noted those events occurred during lower flow conditions and less system demand than what was experienced by the December 19, 2015 event.

Liberty Keene - The blowers are equipped with variable speed drive controls that are sensitive to incoming 3-phase power fluctuations.

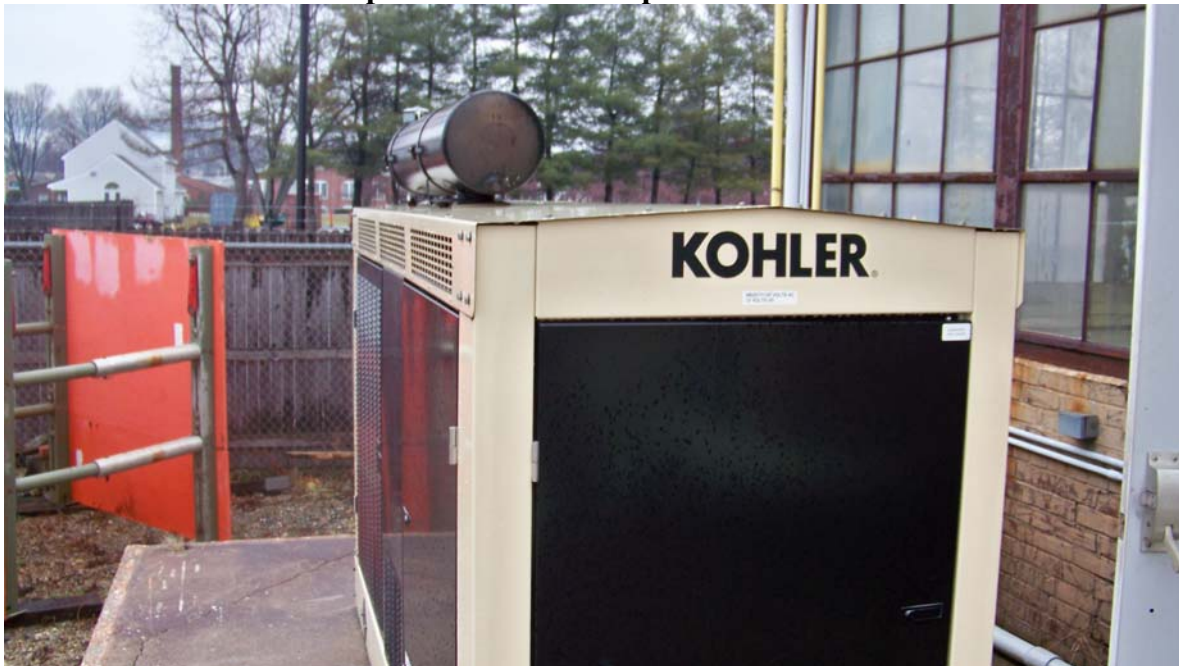
Liberty Keene – The air blowers are equipped with a 125 KW emergency generator.

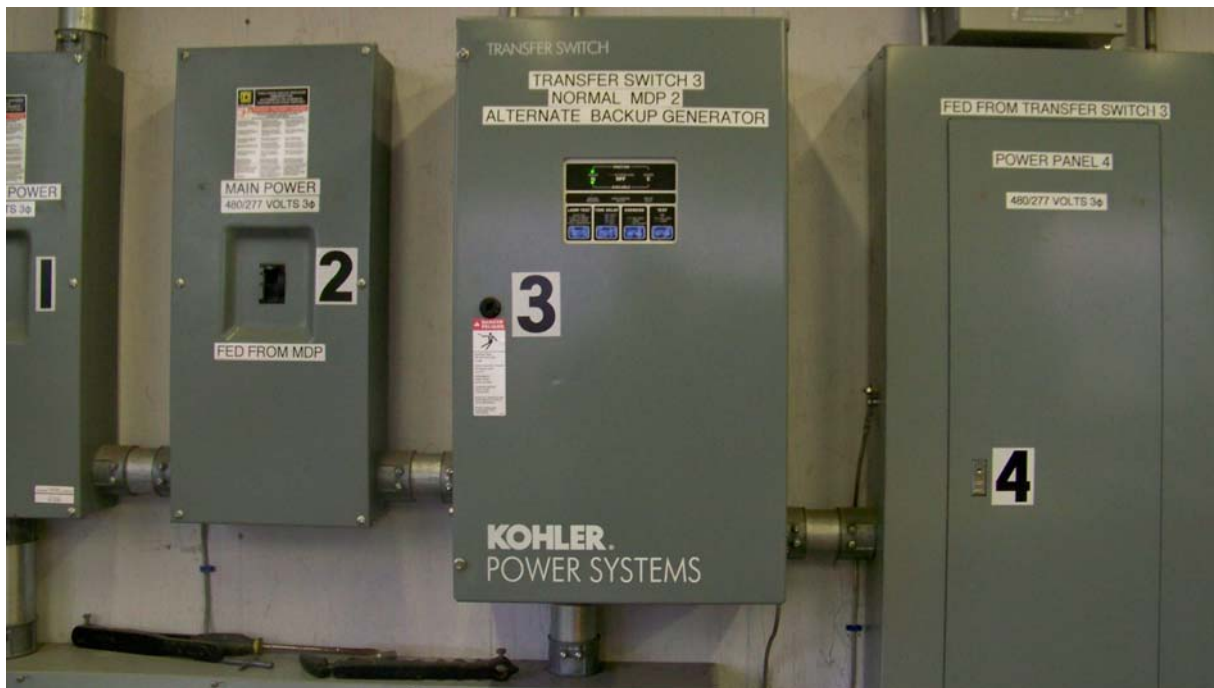
Liberty Keene – The system was not configured to transition to emergency backup power without experiencing a brief power interruption to the variable speed drives which requires manual restart of the blowers.

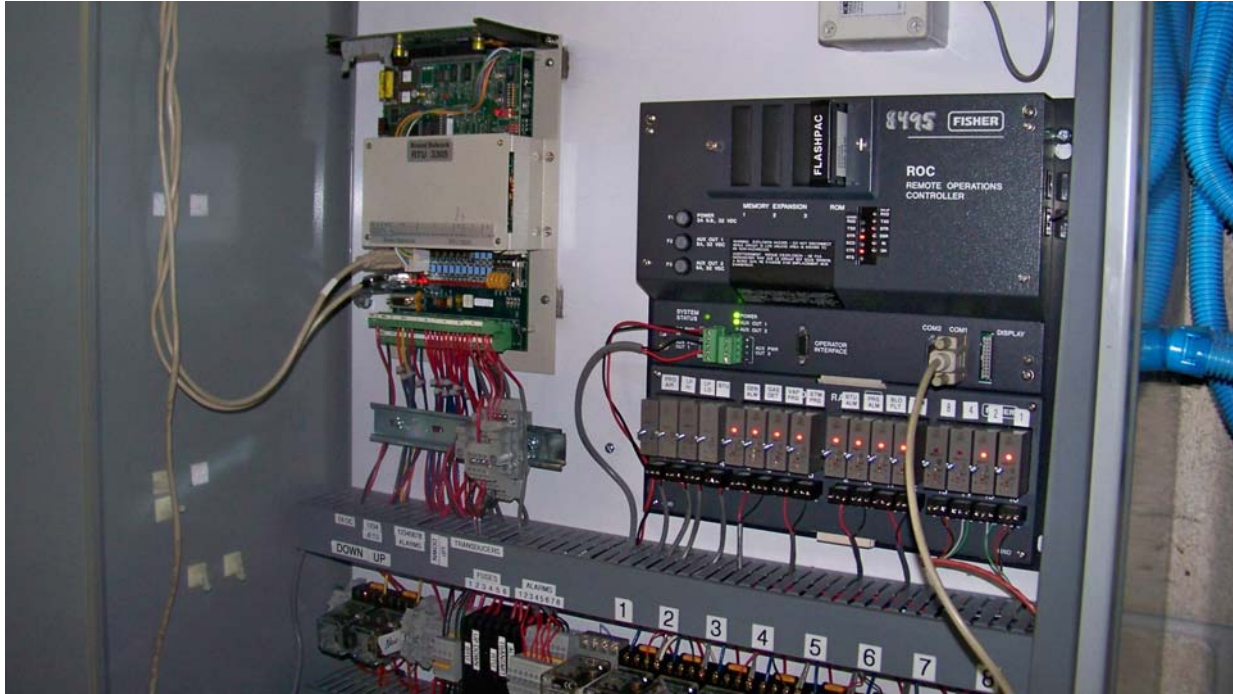
Liberty Keene – The plant is equipped with a remote terminal unit (RTU) that is a microprocessor-controlled device which interfaces analog data from system pressure sensors to the remote operations controller (ROC) which in turn regulates propane and air mixing rates. As the mixture leaves the Keene facility to enter the distribution system, sensors that monitor two constants – pressure and BTU content [a pressure of 3.5 psi in the winter with a BTU content of about 740]. These sensors regulate the fuel and blower systems to automatically respond to greater or lesser customer demand for gas in order to maintain proper pressure and BTU levels.

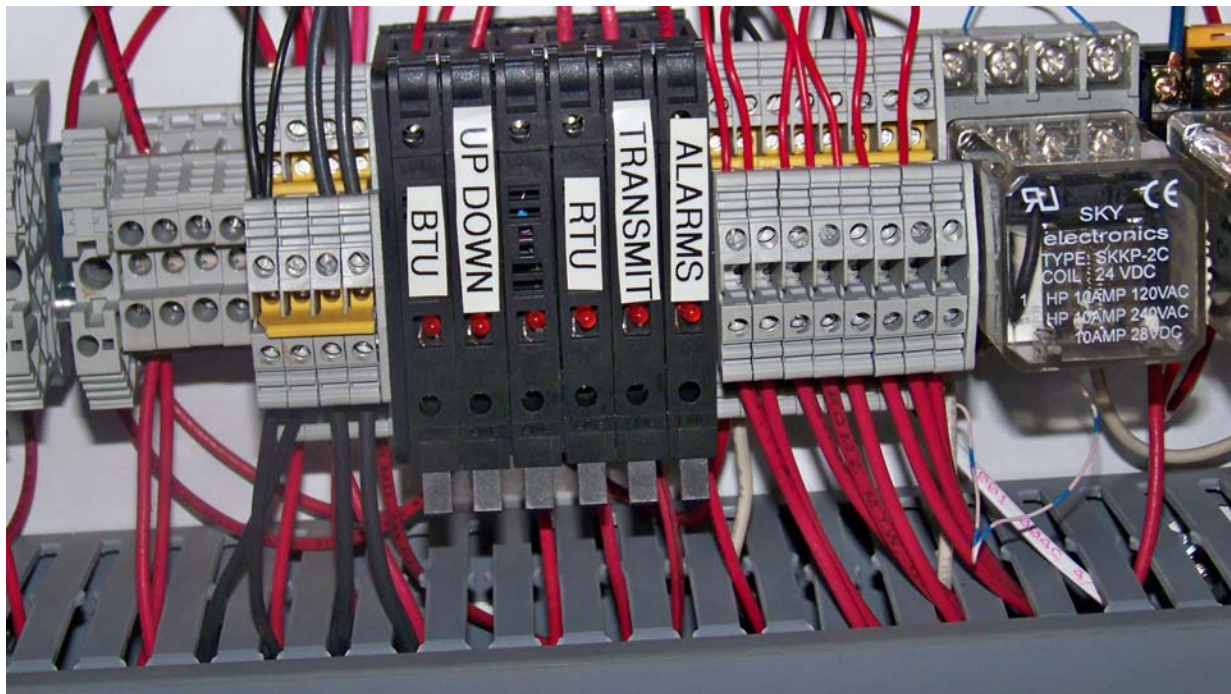
Liberty Keene - Liberty indicated an open fuse in the alarm board circuitry (#6 from left) prevented the appropriate signal from reaching the RTU based control system, resulting in the system RTU control remaining in blower mode instead of switching to atmospheric mode.

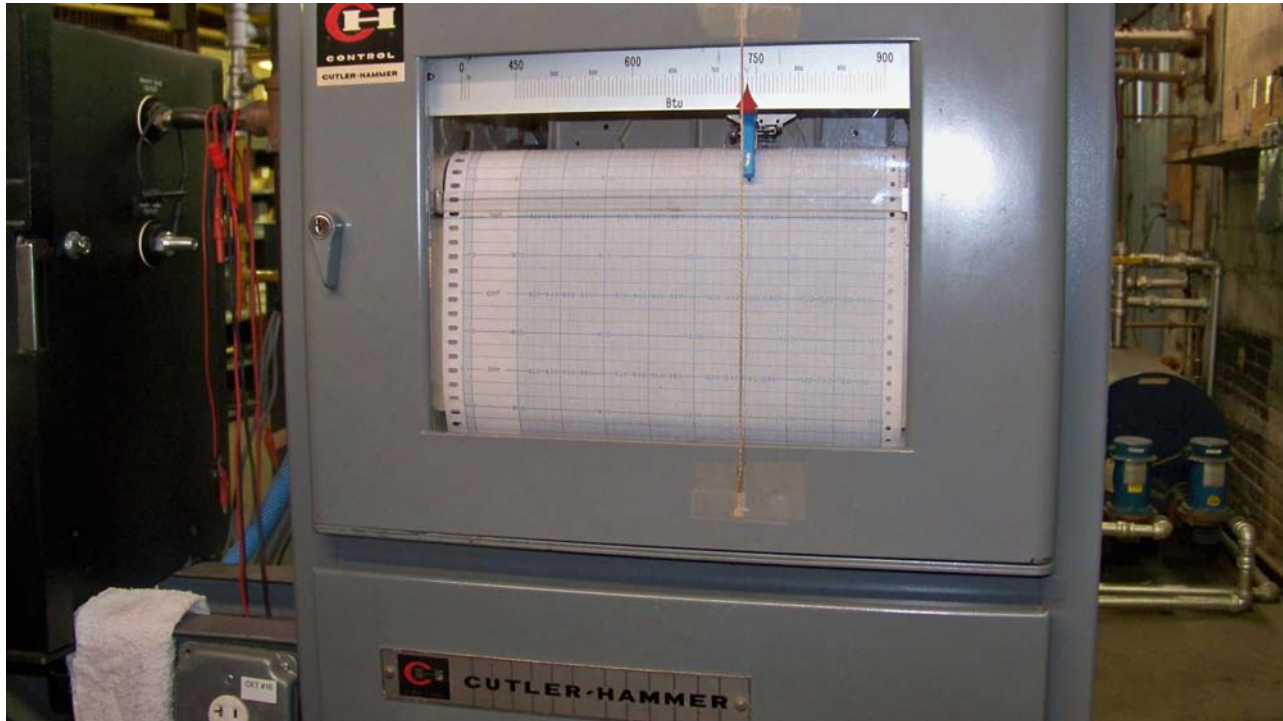
Liberty Keene – The plant propane/air output Btu heating value is monitored and recorded using a Cutler-Hammer calorimeter.

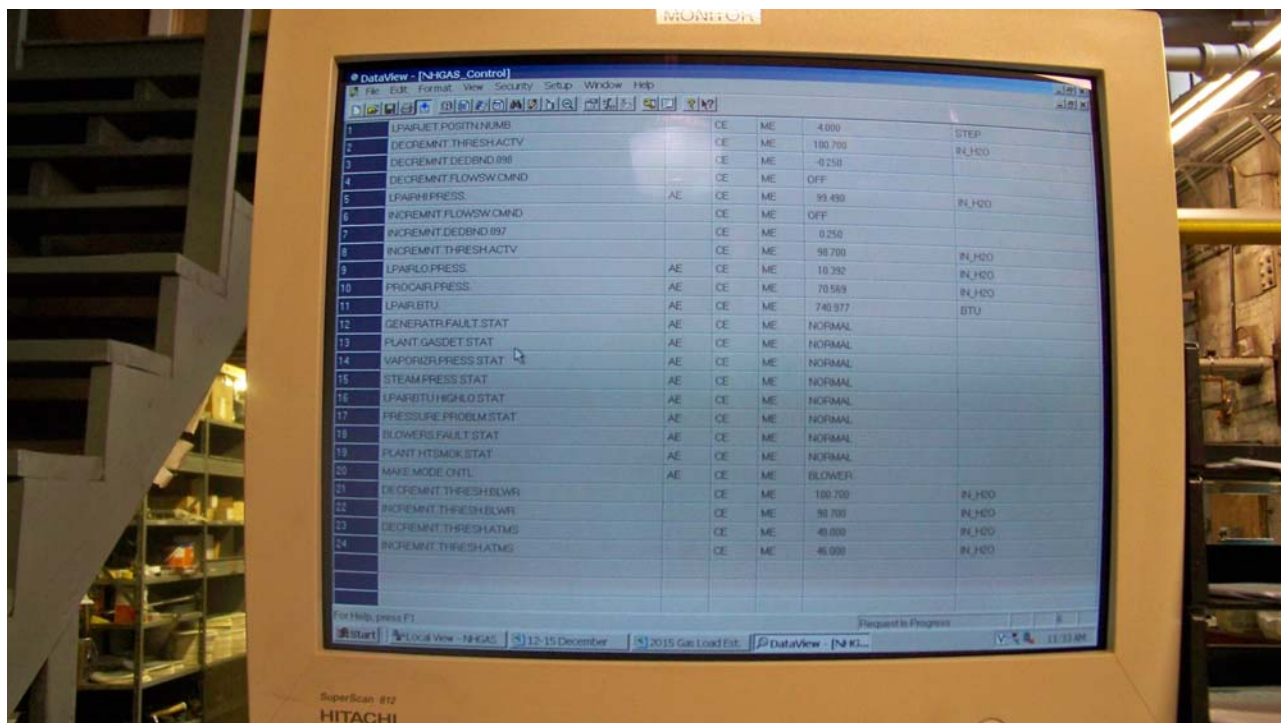
Liberty Keene – System alarms are monitored remotely by Liberty Gas Control as well as Plant Operations personnel.
