**Unitil Energy Systems - Capital  
Reliability Study  
2014**

Prepared By:  
Cyrus Esmaeili  
Unitil Service Corp.  
Sept 15, 2014

# **UES - Capital Reliability Analysis and Recommendations 2014**

## **UES – Seacoast 2014 Reliability Study**

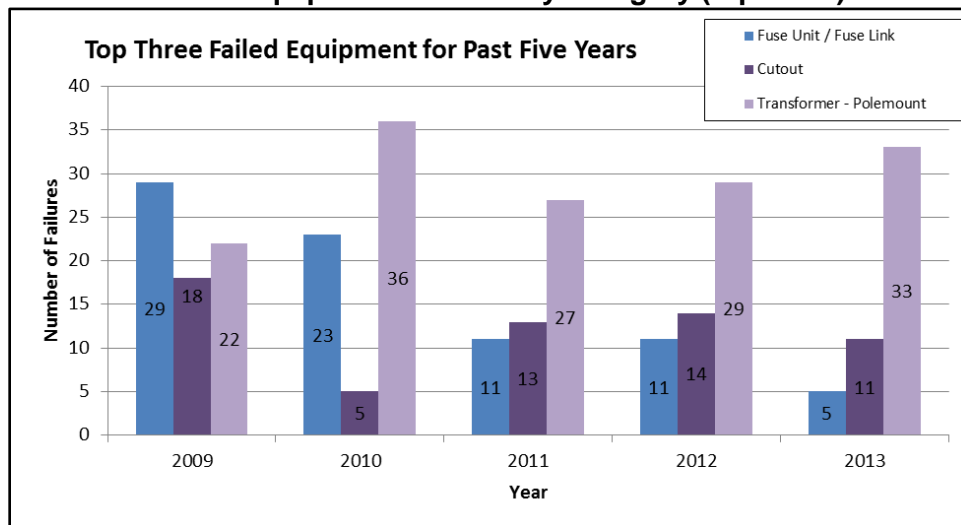
**Chart 4**  
**Annual Equipment Failures by Category (top three)**

Note: Other-Specify is not included in the top three categories. None of the Other-Specify equipment had more than two outages for any specific type of equipment.

This section is intended to clearly show all equipment failures throughout the study period from January 1, 2013 through December 31, 2013. Chart 2 shows all equipment failures throughout the study period. Chart 3 shows each equipment failure as a percentage of the total failures within this same study period. The number of equipment failures in each of the top three categories of failed equipment for the past five years are shown below in Chart 4.
